Unique Issues, Challenges & Needs of a Coral Atoll Airport in Operating and Achieving Safety Compliance

**FAA Western-Pacific Region
4th Annual Airports Conference
Westin Los Angeles Airport Hotel
Los Angeles - 6-8 May 2008**

Experiences from Majuro International Airport Republic of the Marshall Islands

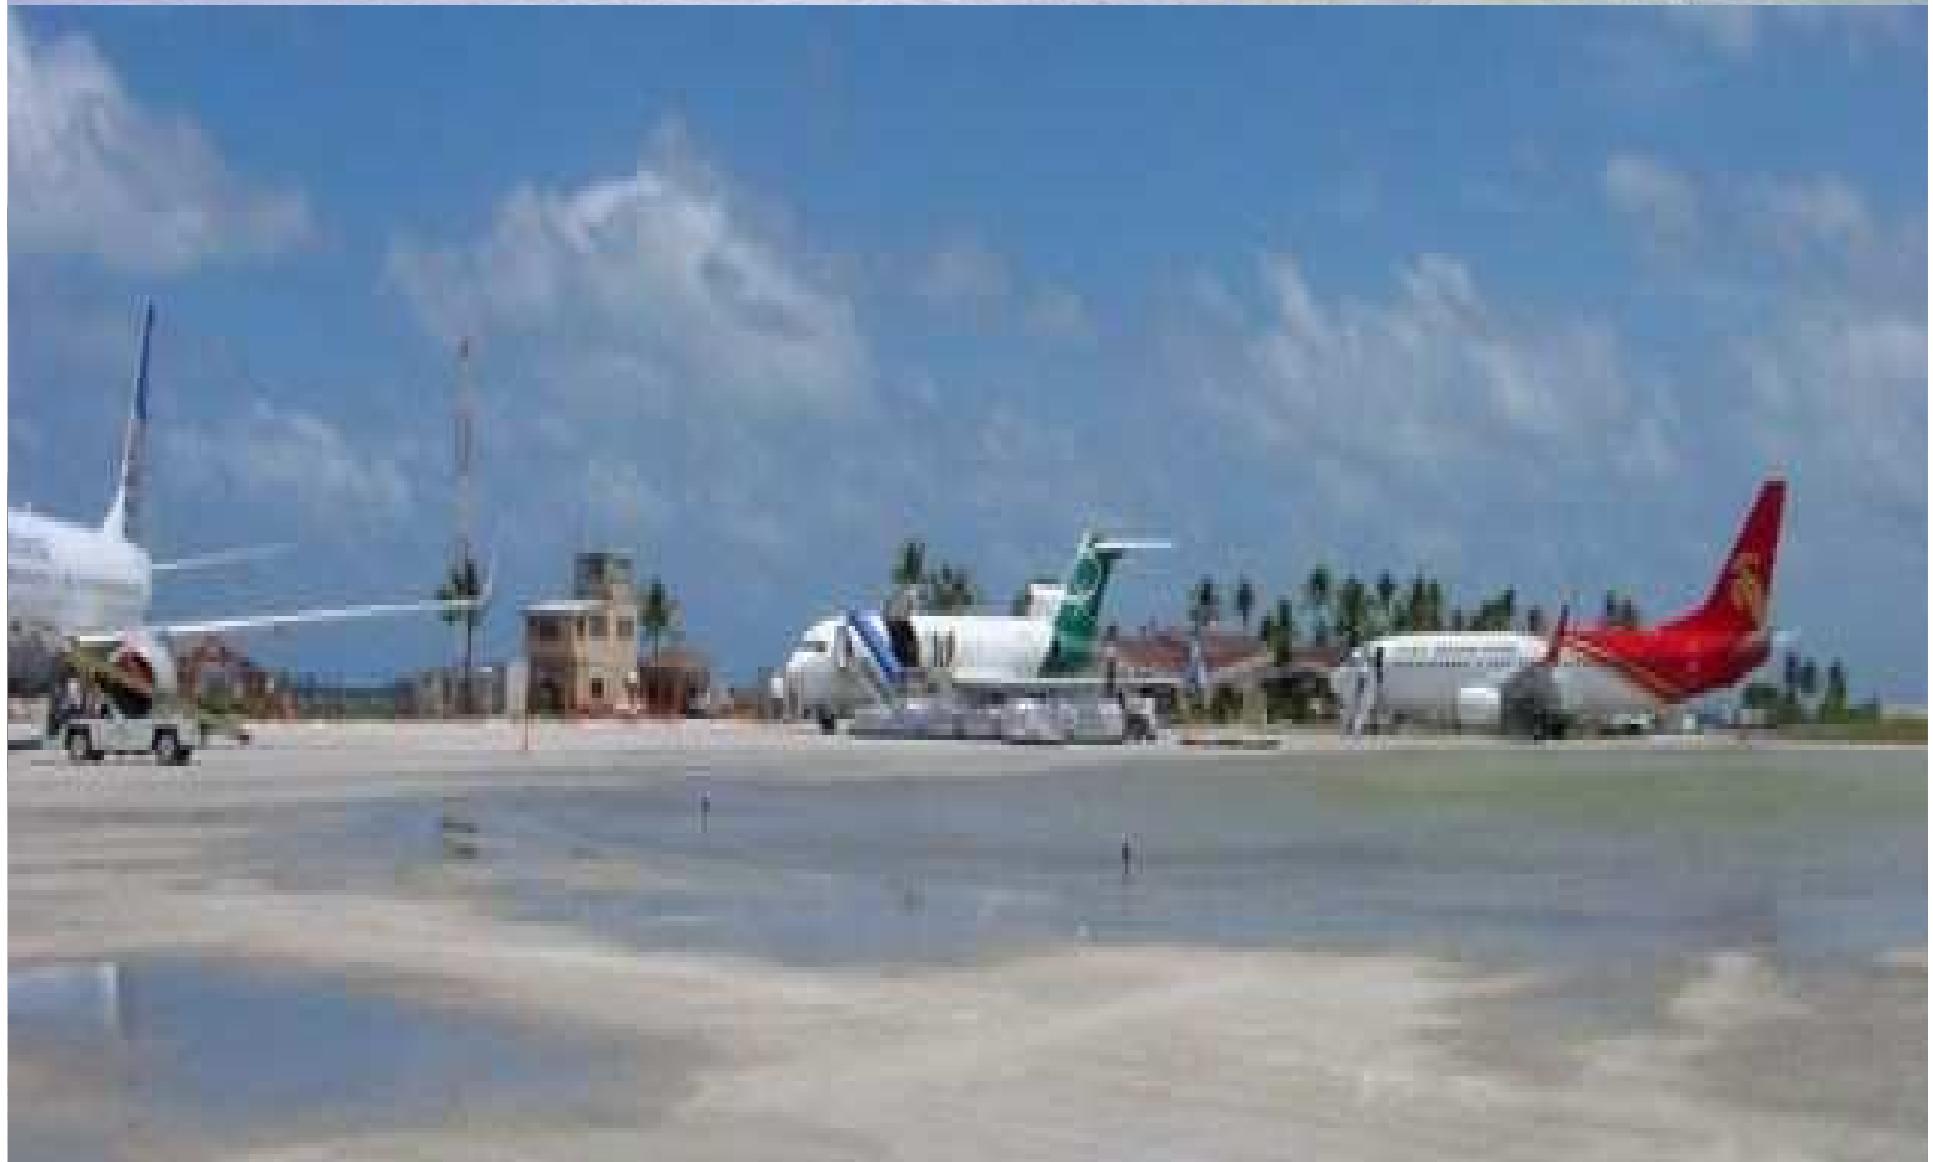
Apron Congestion

- Harsh Environment Rapidly Degrades Improvements and Increases Maintenance Costs
- Limitations on Land Availability
 - Affecting operational clearances
 - Land availability for infrastructure development and airport equipment
 - Vehicle parking area by terminal building
- Limited Apron Area

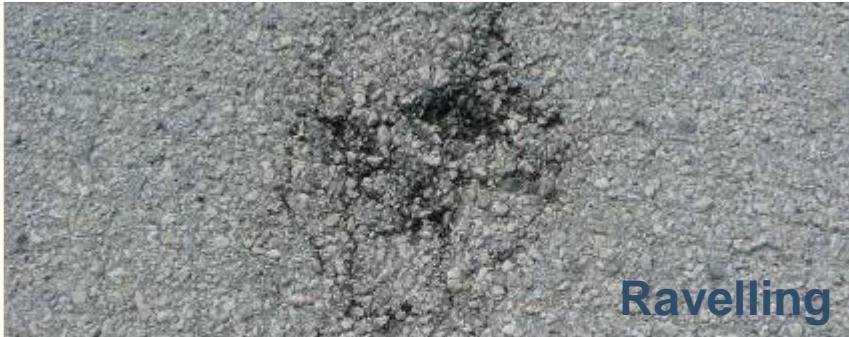
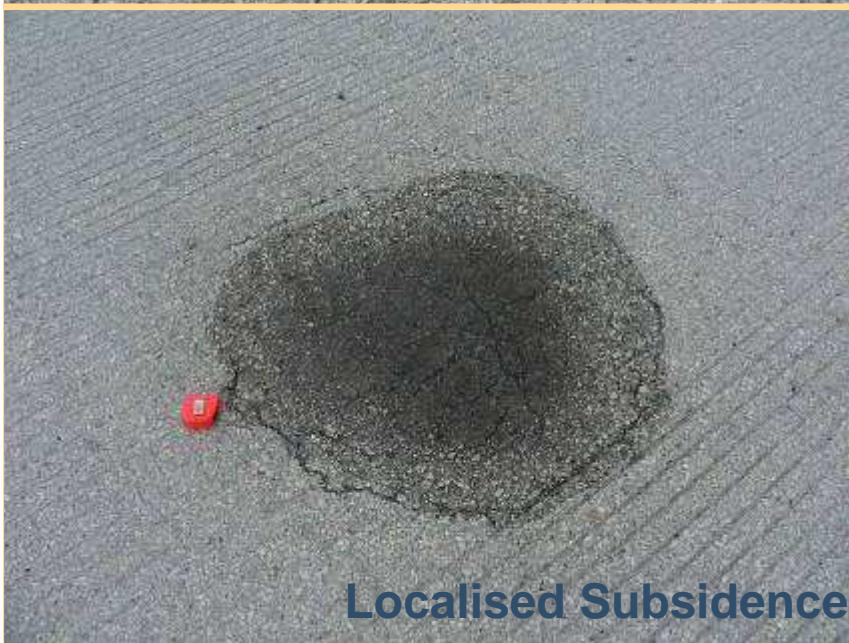
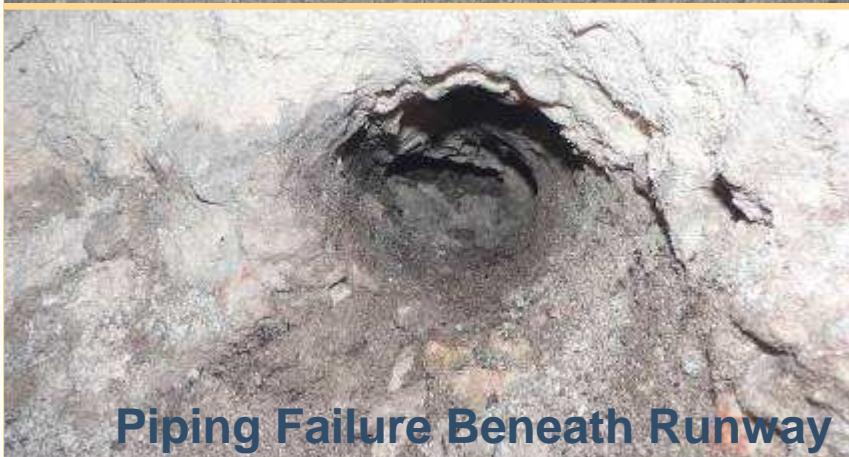
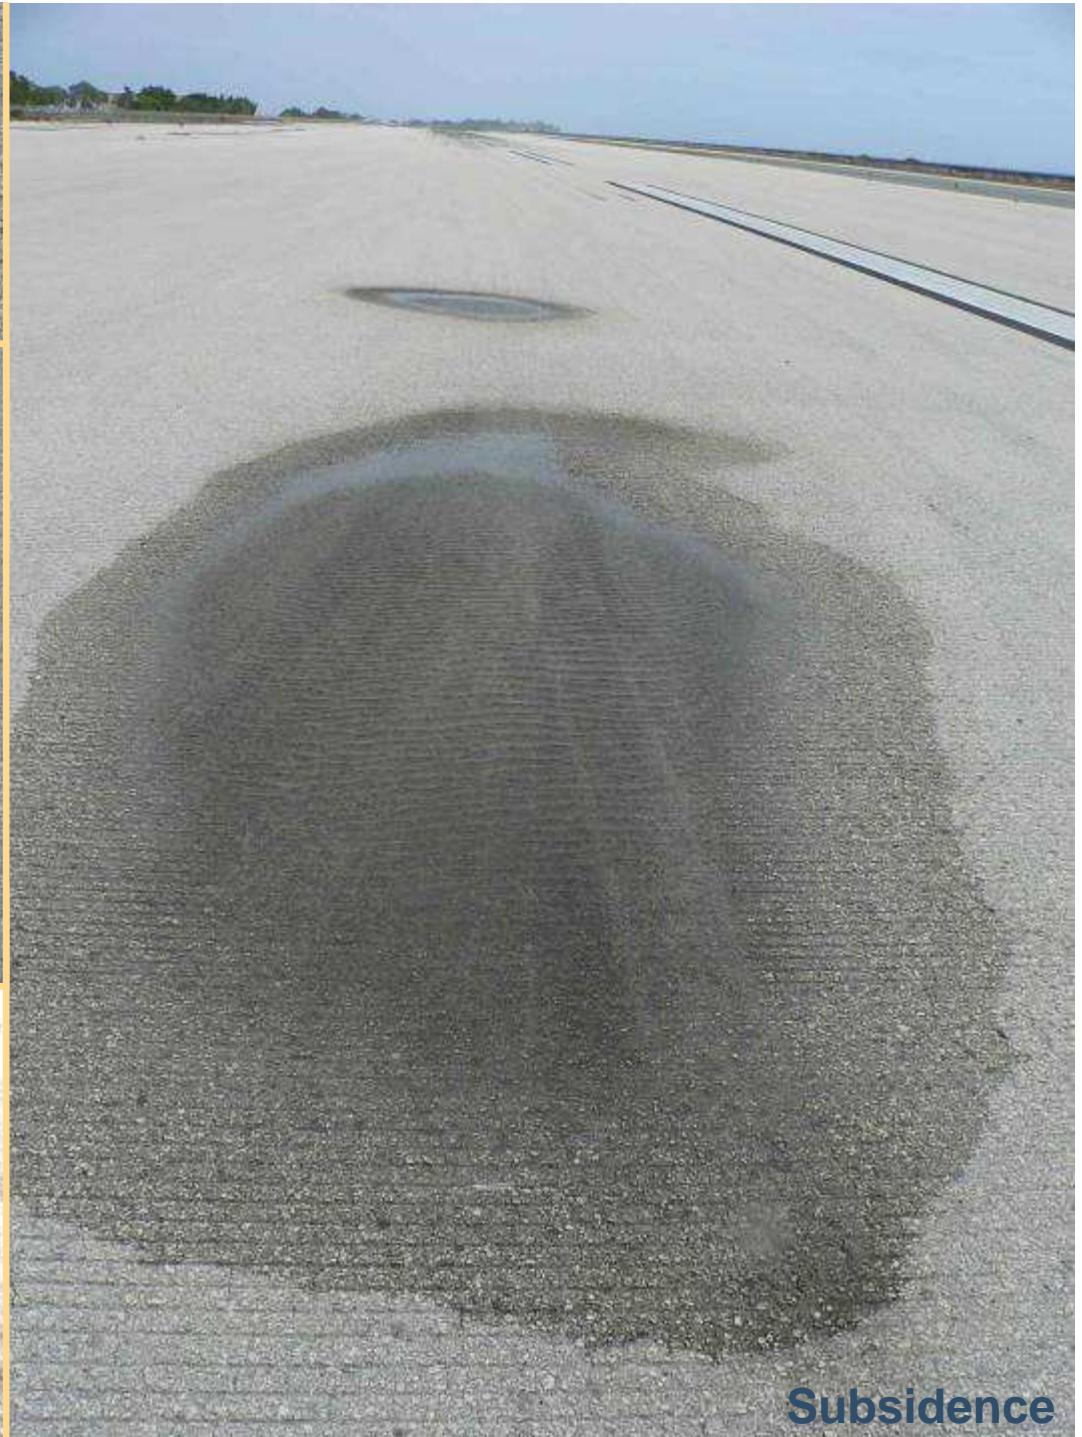
Majuro Runway Upgrade Project

Compliance issues

- Failure of the runway pavement
- FOD generation
- Limited visible paint markings
- No aircraft turning bay at Runway 07
- Runway lighting vulnerable
- Breathers within RSA not frangible

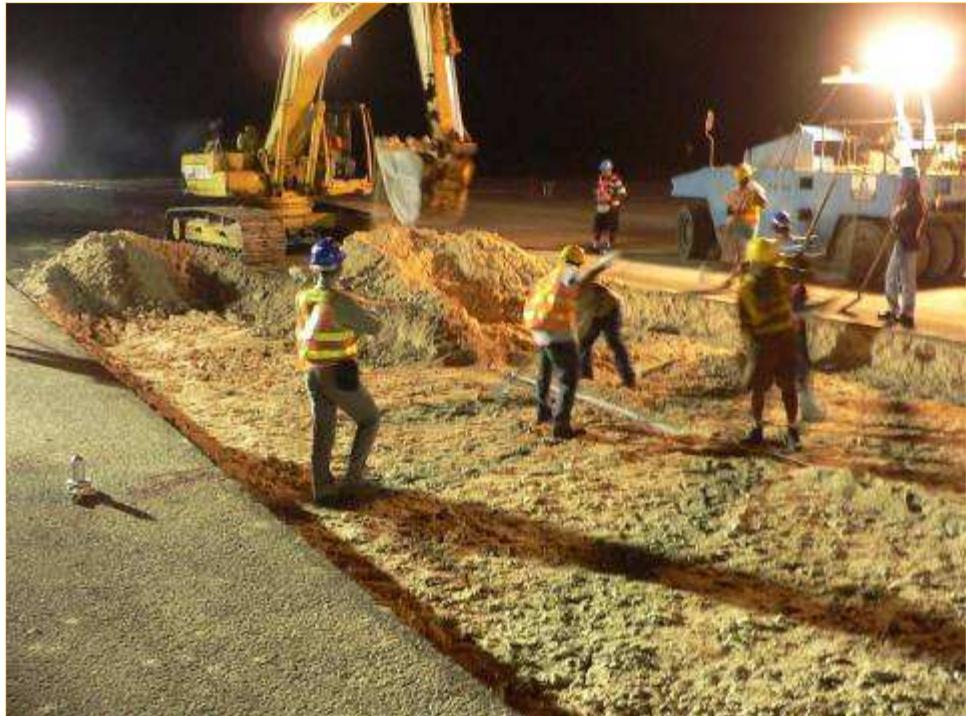
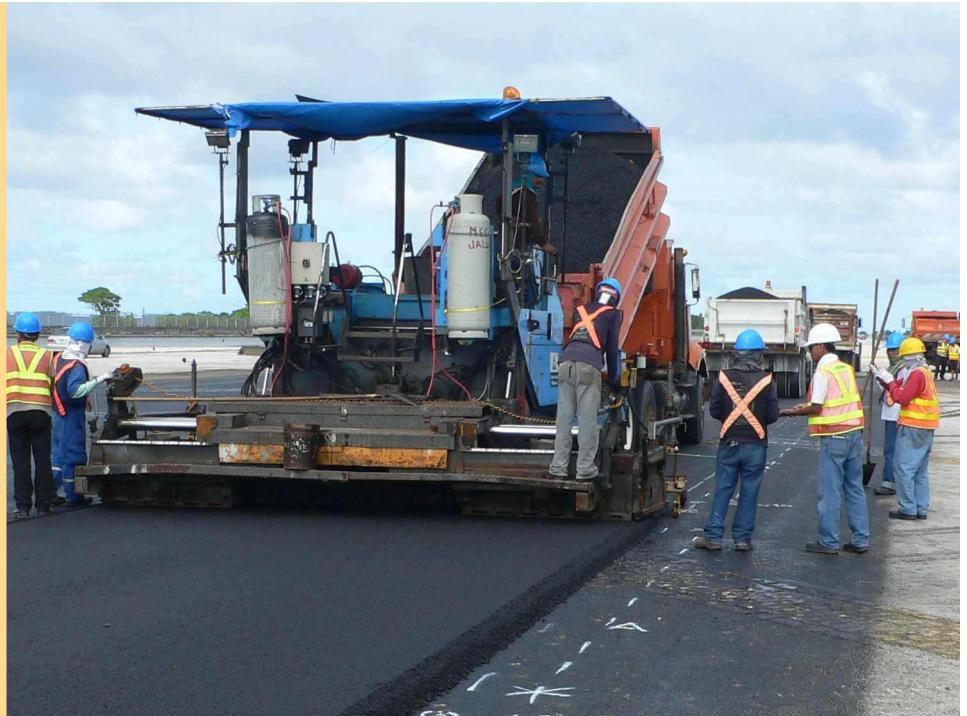
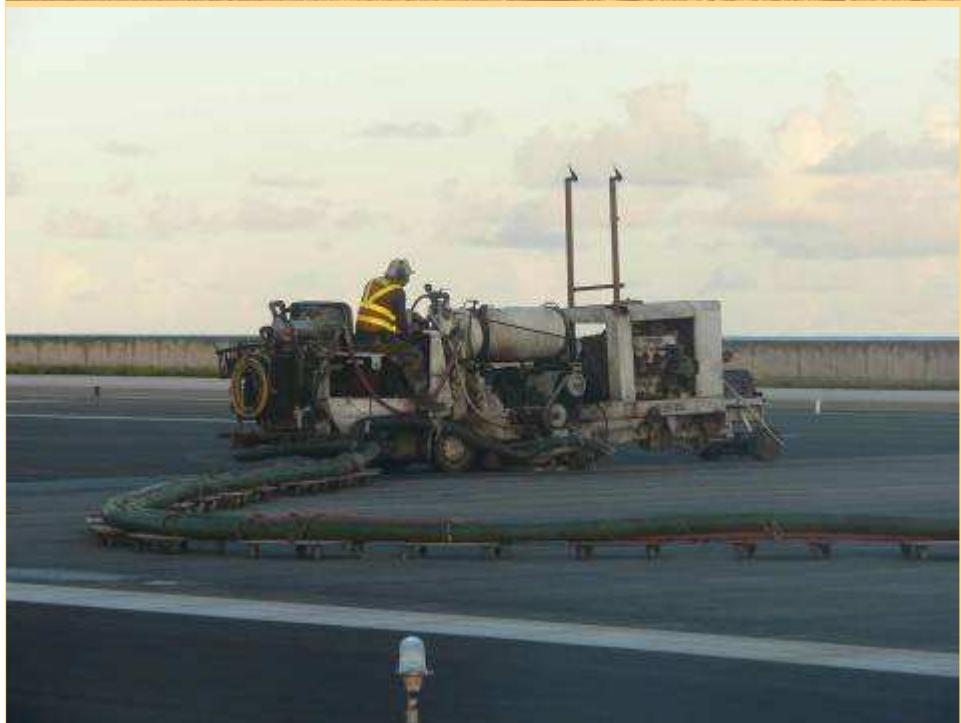
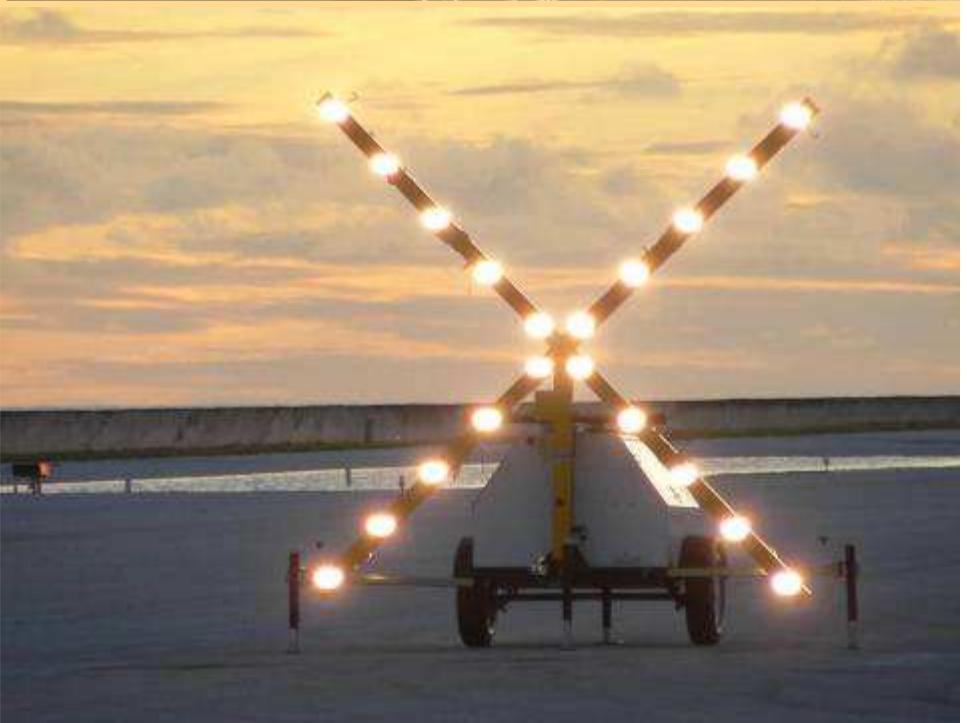
Completed Majuro Runway Upgrade

Runway safety improvements – 2005/2006

- Grooved structural asphalt overlay
- Shape correction
- Runway shoulders
- New turning bay with edge lighting
- Precision paint markings
- Upgrade runway lighting system
- Frangible breathers

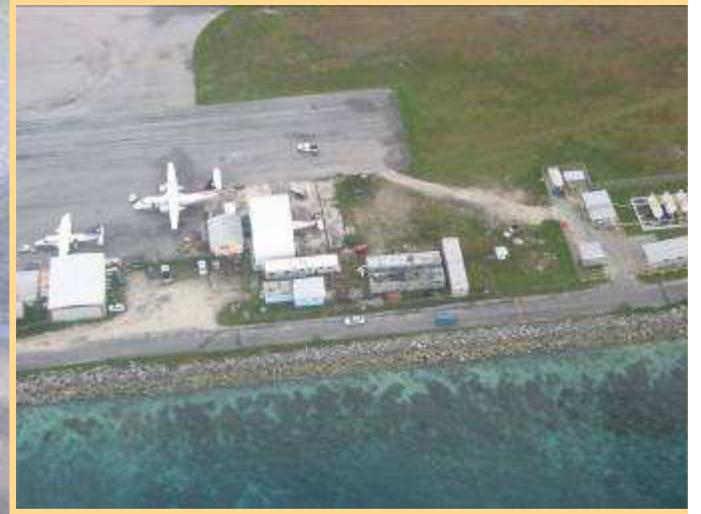
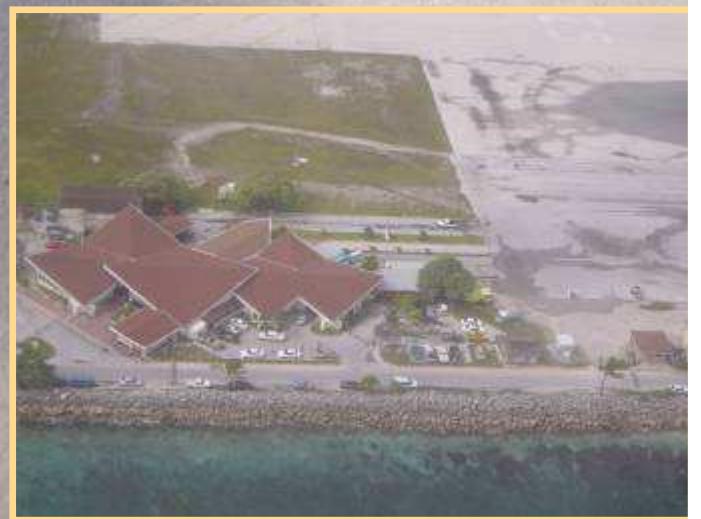
Majuro Apron Rehabilitation Project

Compliance issues

- Obstructions penetrating the FAR 77 transitional surfaces
- Apron congestion
- Mitigation of potential FOD
- No control/protection against jet blast
- Poor apron drainage
- Taxiway shoulders
- Substandard illumination
- Security fencing

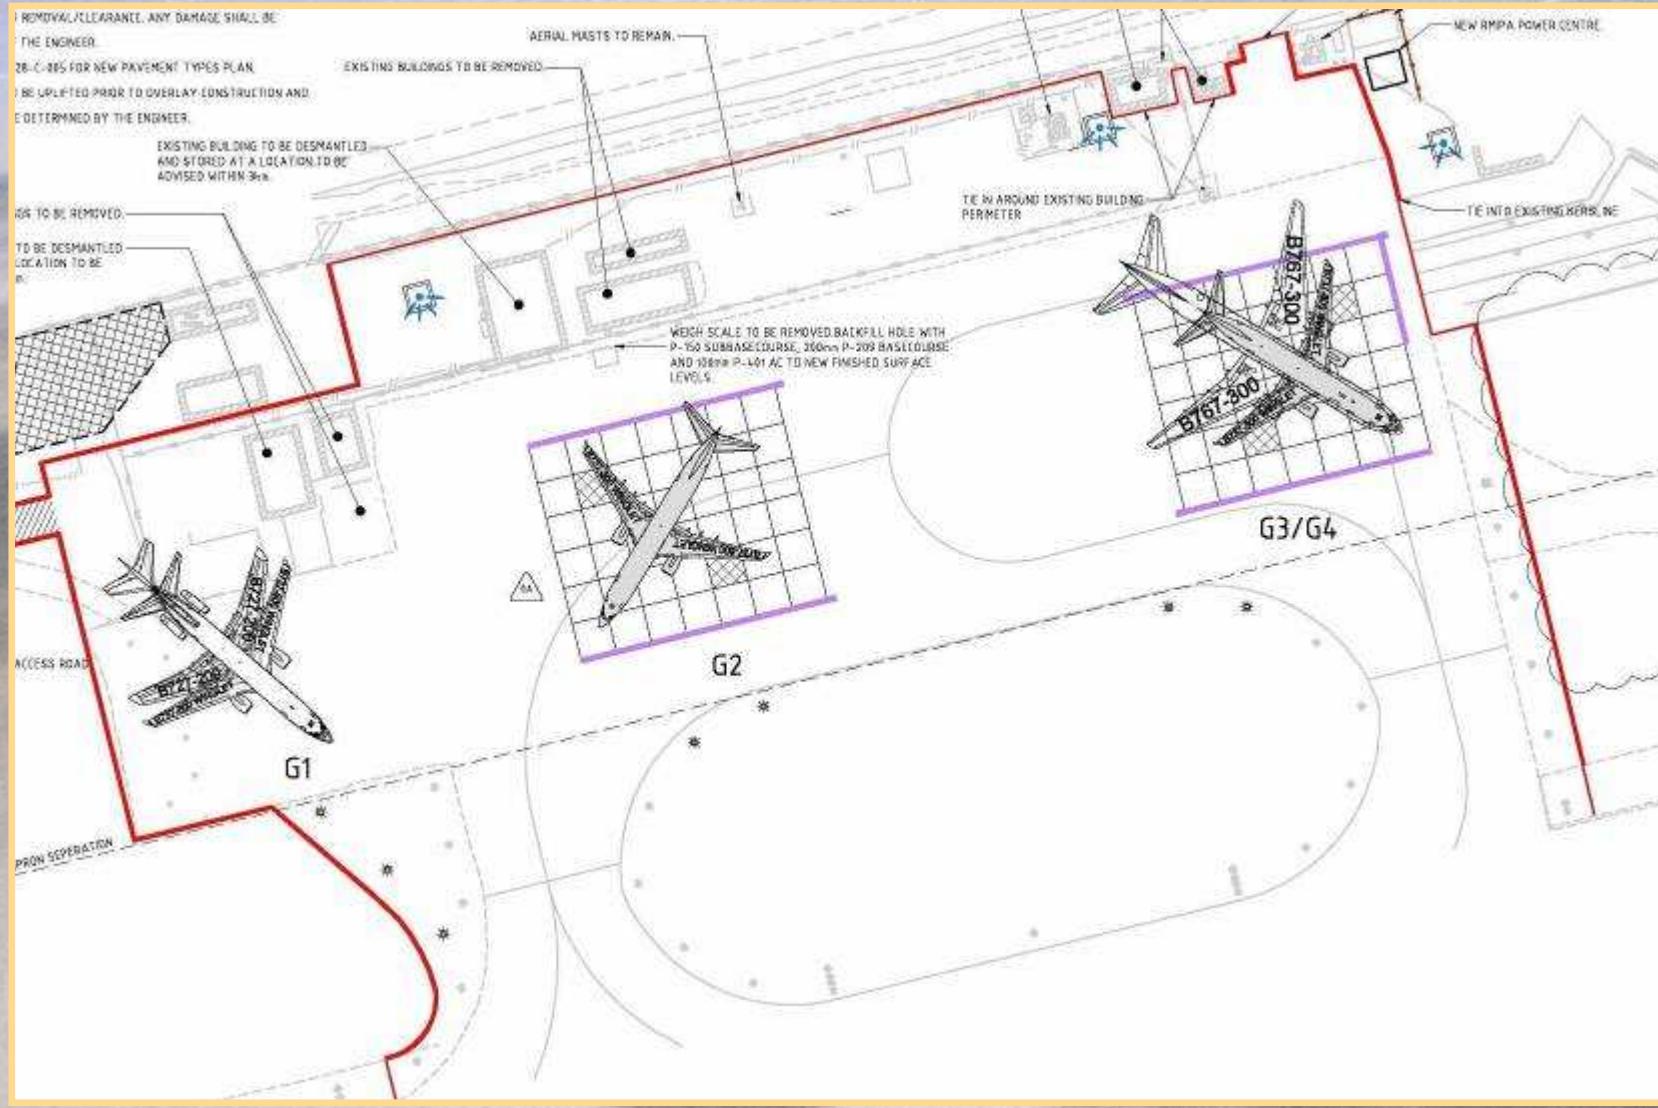
Majuro Apron Rehabilitation Project

Apron safety improvements – 2007/2008

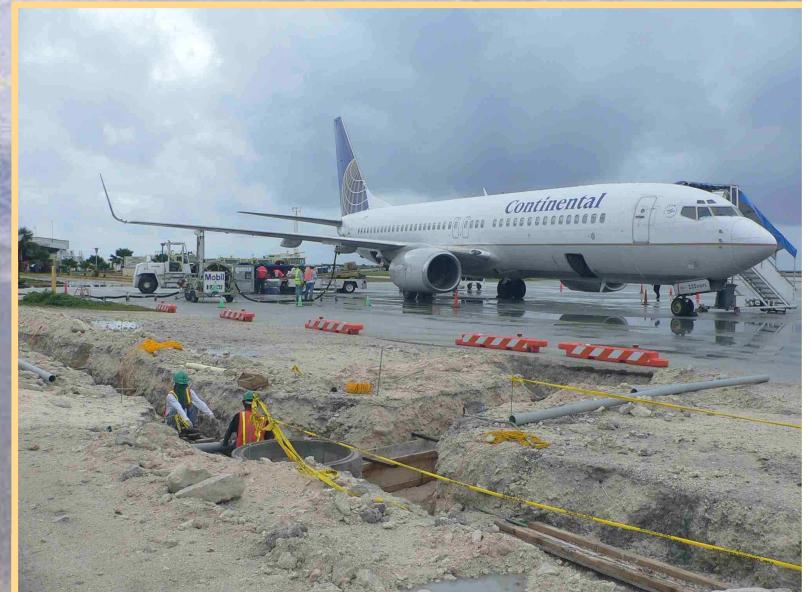
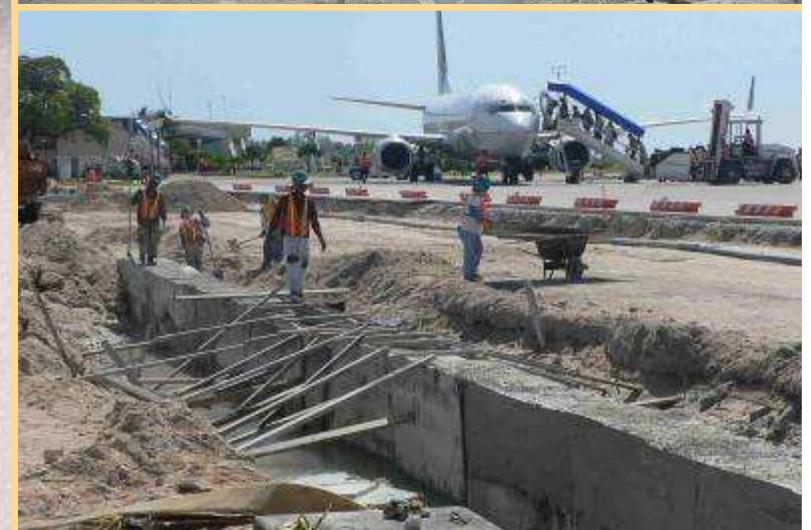
Majuro Apron Rehabilitation Project

Apron safety improvements – 2007/2008

- Three jet capable gates
- Asphalt overlay and concrete hardstands
- Minimise obstruction
- Apron floodlighting
- Improving apron drainage

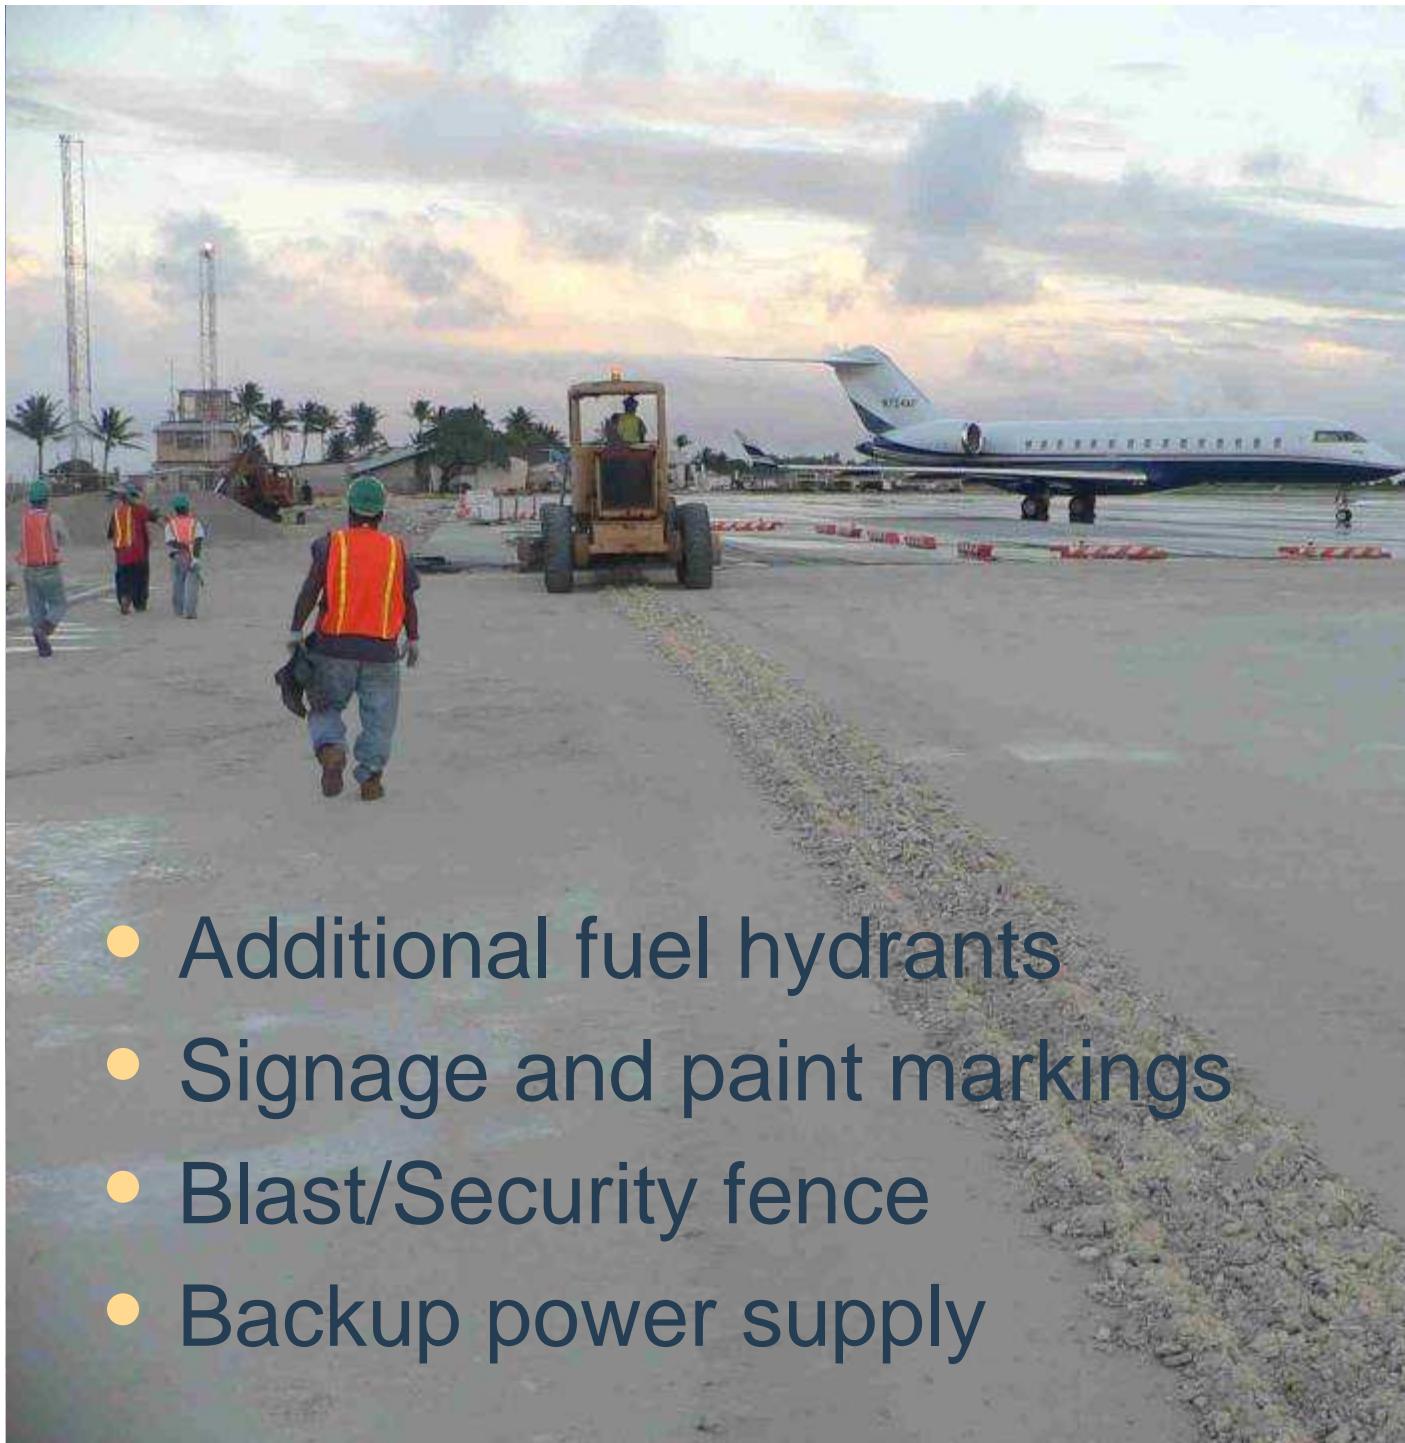
- Additional fuel hydrants
- Signage and paint markings
- Blast/Security fence
- Backup power supply

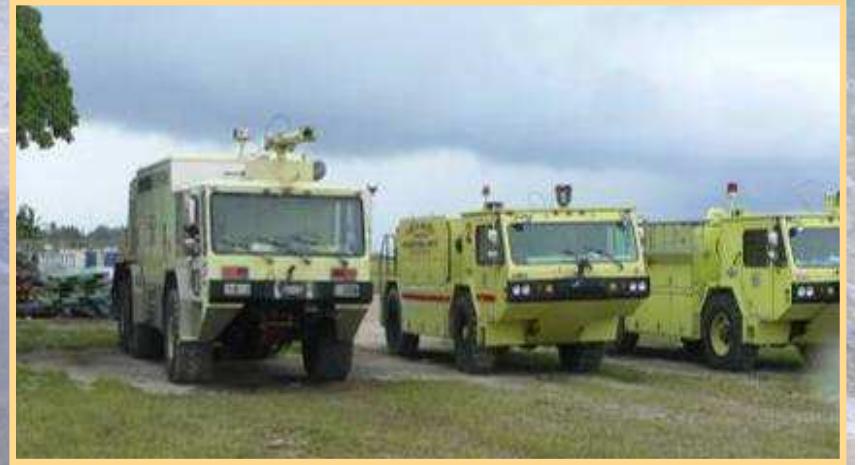
- Very old ARFF vehicles
 - Frequent breakdowns
 - High maintenance cost
- No airport firefighters
- Inadequate and worn out firefighting gears and equipment
- No training room for firefighters
- Very limited training in emergency response
- Limitations of re-servicing of ARFF vehicles

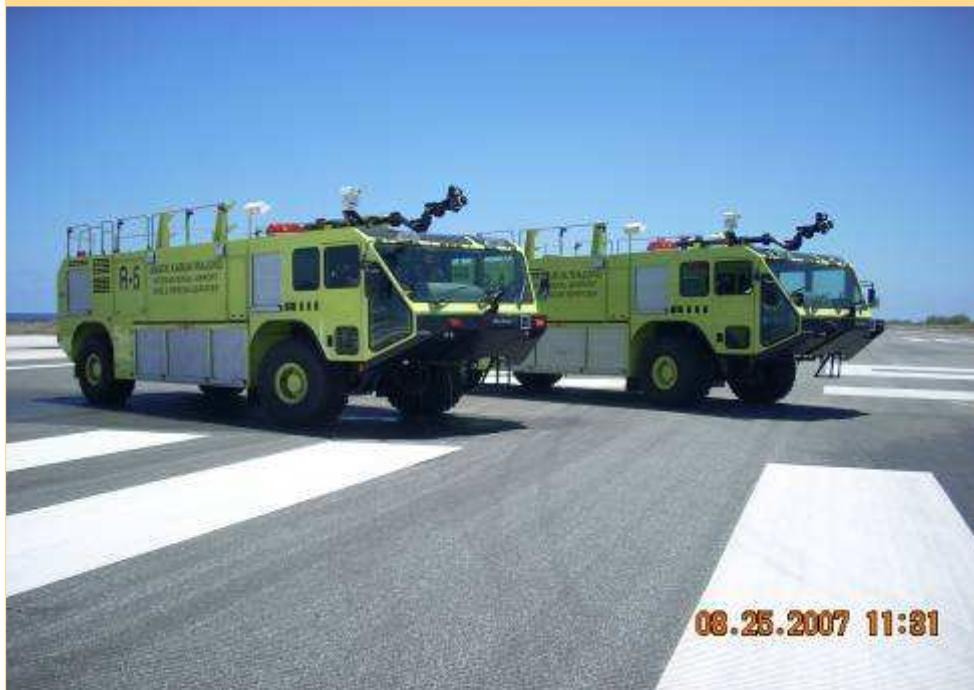
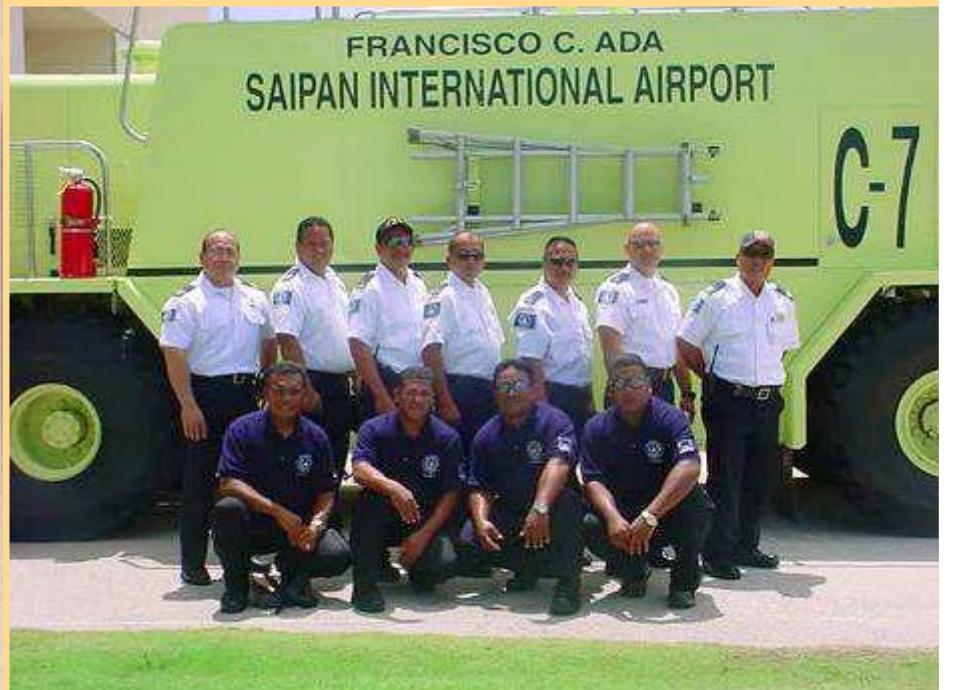
ARFF Personnel, Vehicles & Equipment

Safety improvements

- Two Oshkosh, 1500-gallon ARFF vehicles
- 11 ARFF Staff, Pro-Board certified
- New gears and auxiliary equipment
- Training room to be provided with ARFF bldg.

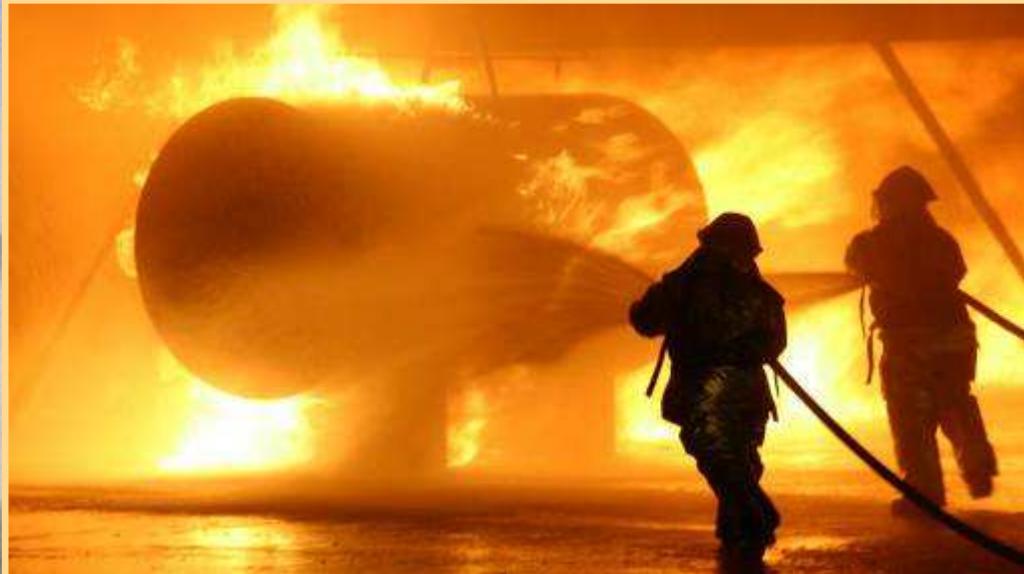
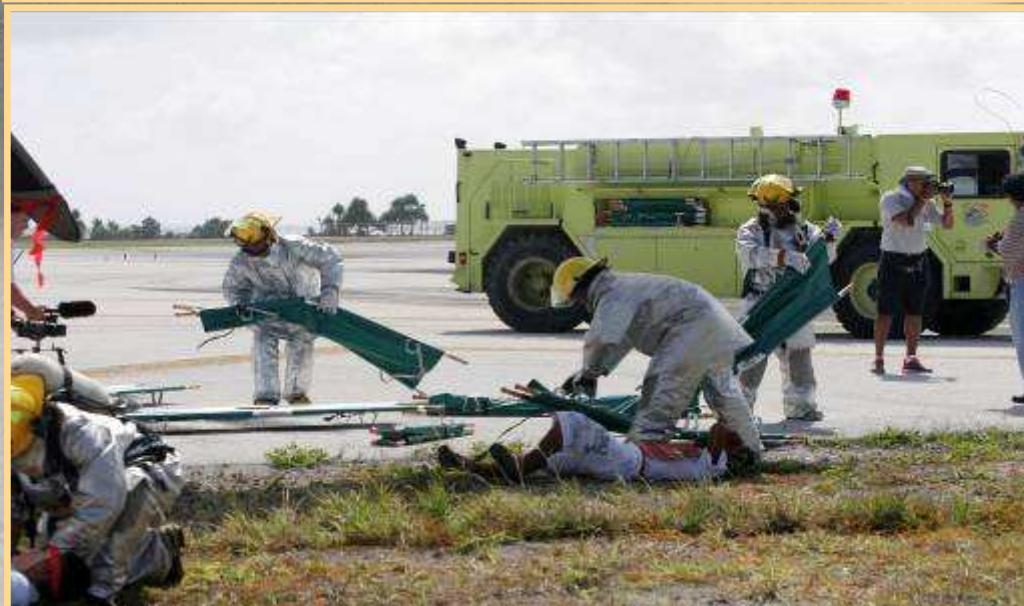
- Airport emergency operations conducted by FAA, i.e. full-scale emergency exercise
- Foam supply provided with new ARFF trucks
- Water re-servicing capability with new ARFF building

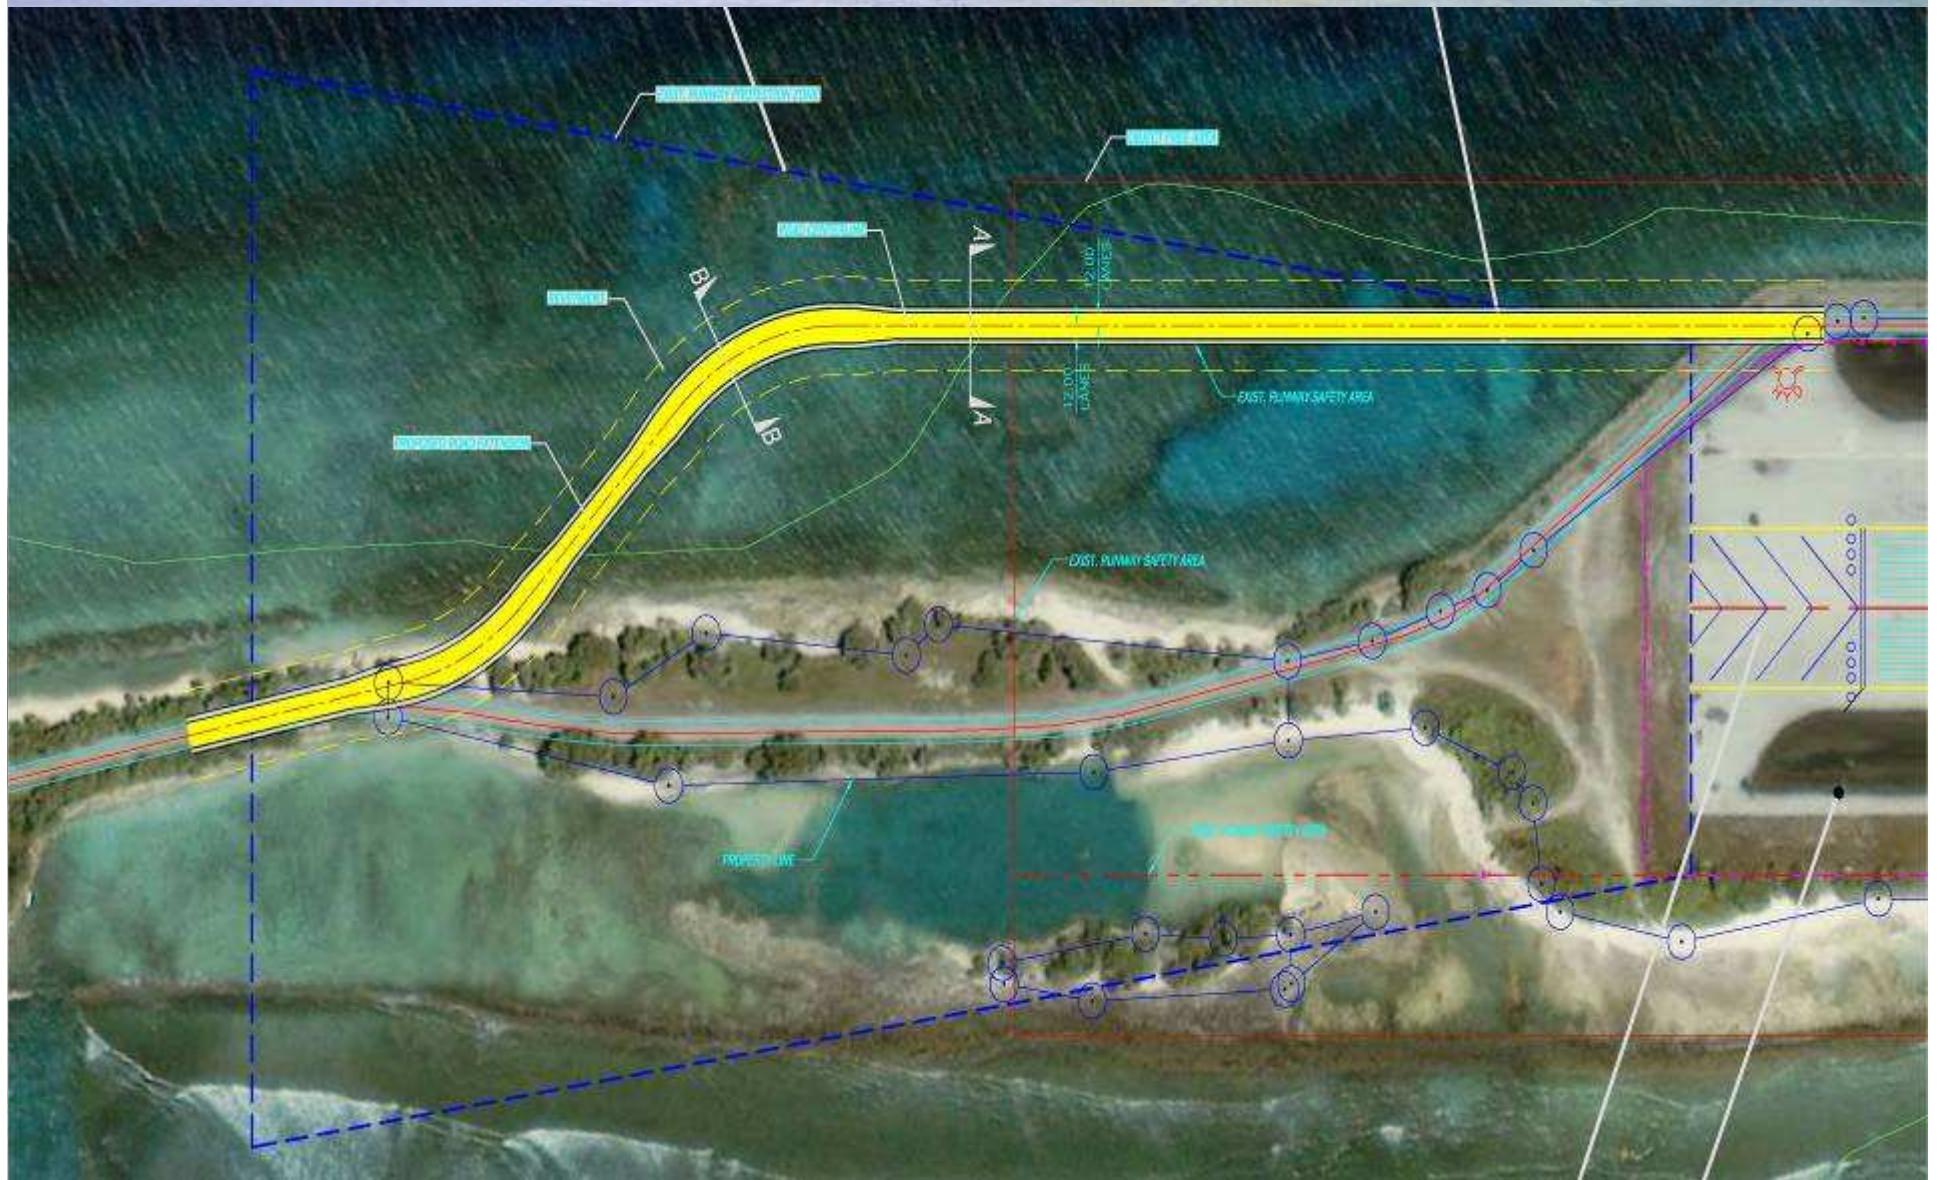
Runway 07 RSA Improvement Project

Safety improvements

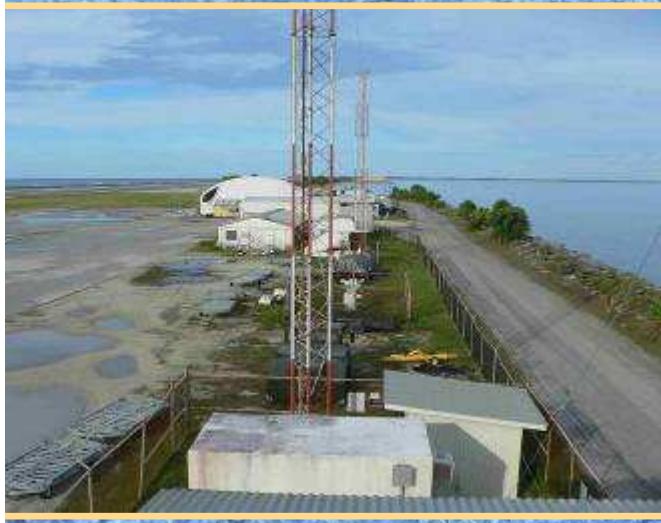
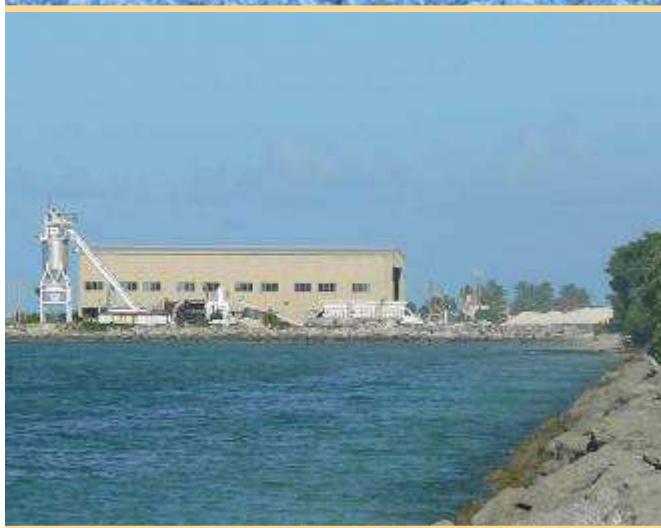
Project Planning & Design

- Airport Master Plan
- Local preference
- FAA and government regulations
- Stainless steel/epoxy coated/fibreglass reinforcing bars
- Pavement testing
- Survey datum's
- Coral construction materials

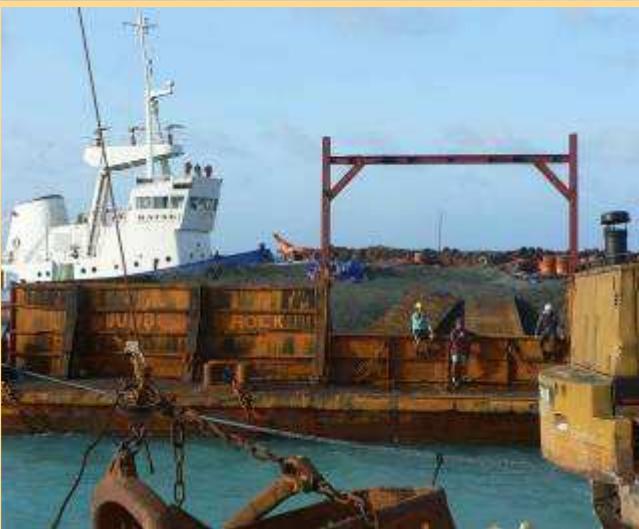
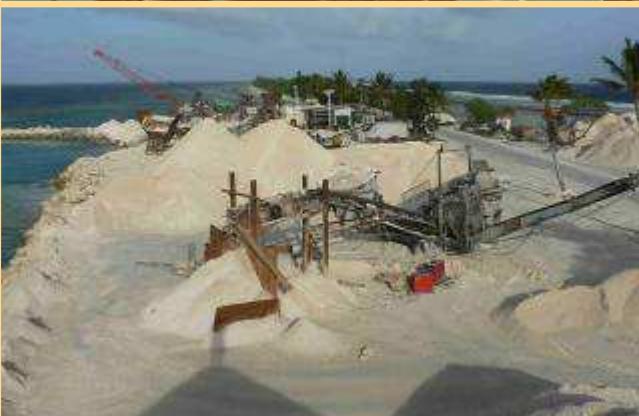
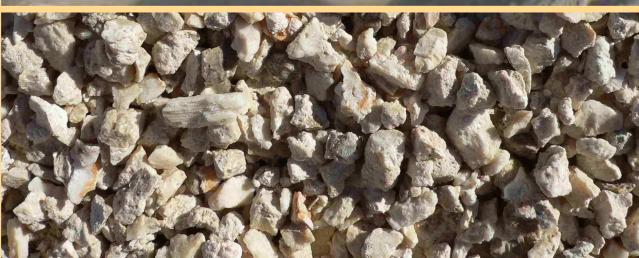
Construction Logistics

- High establishment costs
- Mobilize all specialist equipment
- Increased risk of delay
- Lay down space limited
- Fuel and water supply
- Laboratory certification
- Lack of local skilled labor
- Immigration
